Safespill Systems IBC Tote Flare-up Test Report

April 2018

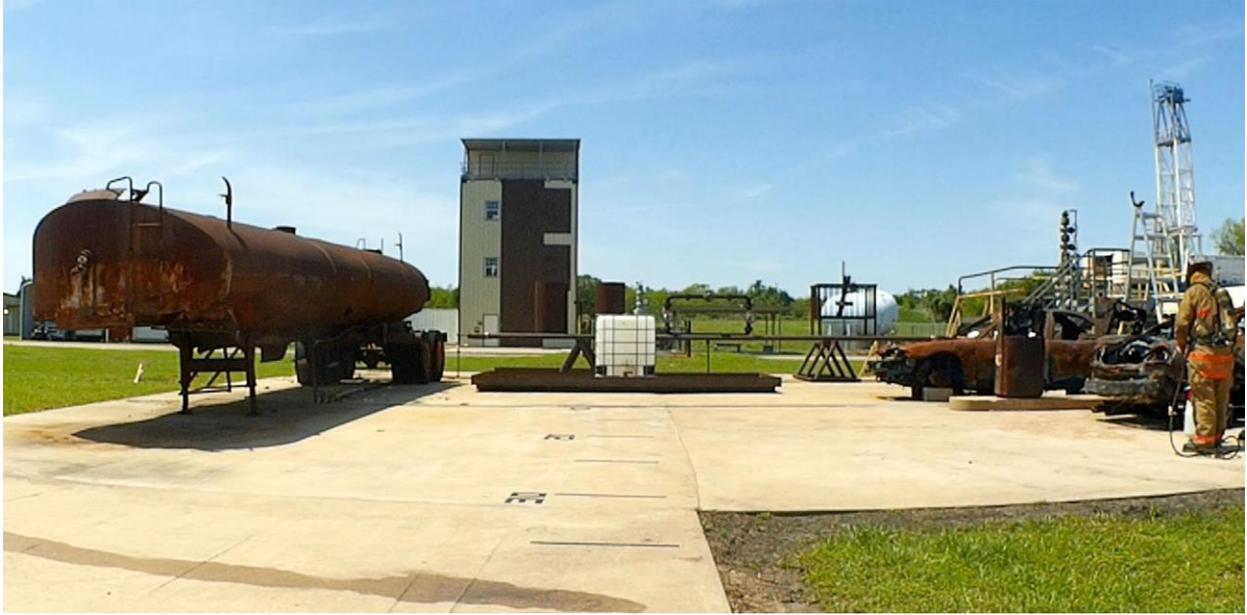
Figure 2.2: Testing Area from Front Camera

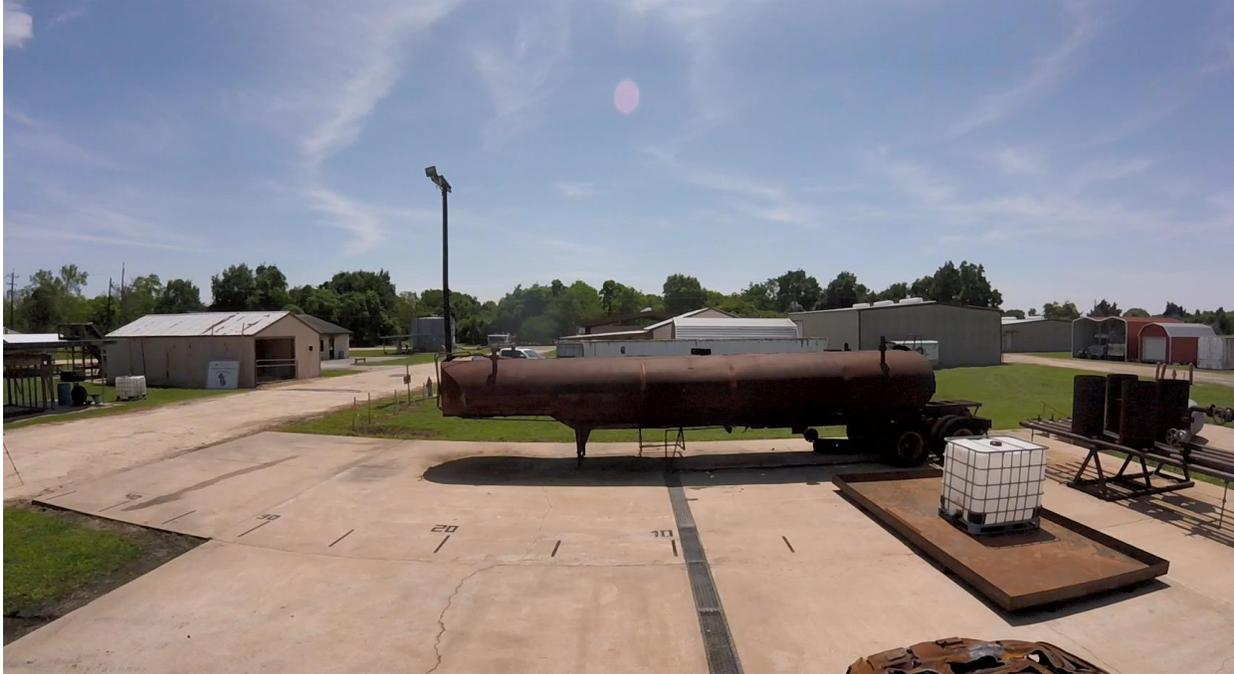
Figure 2.3: Testing Area from Side Camera

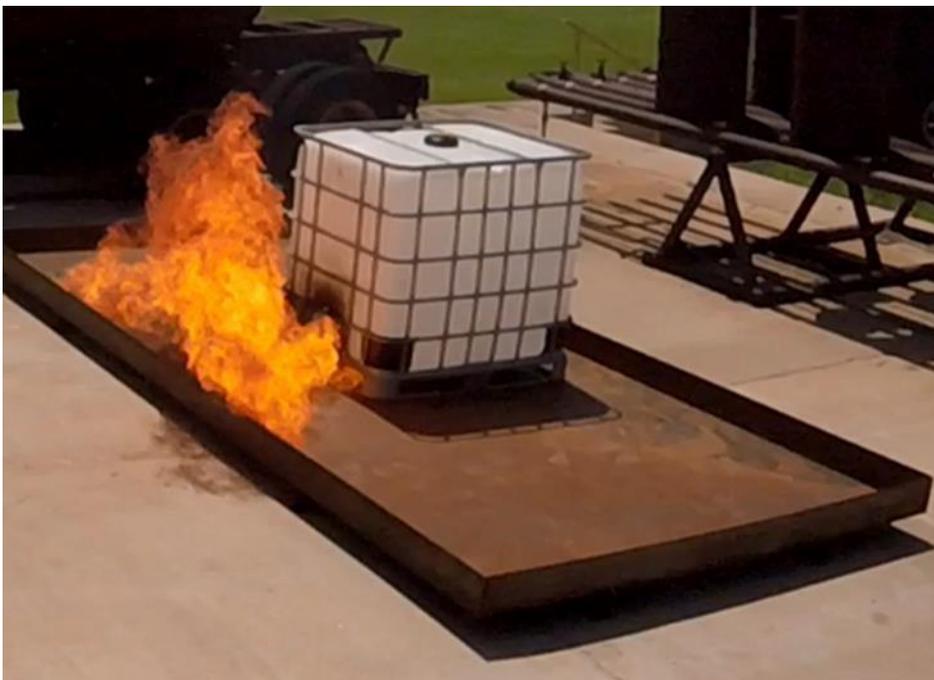
Figure 3.1: Gasoline Flare-up (2:09)

The test began with the ignition of a rolled cotton igniter. After 90 seconds, the tote was breached inside of the doghouse, above the liquid level. An audible release of vapor accompanied the visible breach. At 2 minutes and 9 seconds, a large flare-up occurred, as shown in Figure 3.1. Following this vapor release, the fire was reduced to the size that was observed before the flare-up. At 2 minutes and 50 seconds, fire-fighting measures began and the test was terminated.

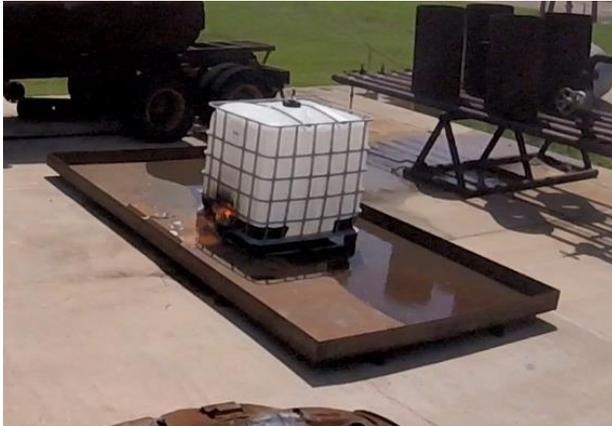
Figure 3.3: IBC inflation and initial vapor release

The test began with the ignition of a rolled cotton igniter. At 1 minute and 38 seconds, a major flare-up occurred. The flare-up began with a visible pressure buildup inside of the IBC (Figure 3.3), followed by a release of ignitable vapor (Figure 3.4). This vapor cloud was ignited, leading to a massive fire that engulfed the entire containment pan (Figure 3.5). The design of the pan appears to redirect the expanding gases laterally and the IBC is pushed backward. After the initial flare-up, isolated pool fires remained in the pan, and a plastic fire began to consume the IBC (Figure 3.6). A firefighter intervened at 2 minutes and 20 seconds, extinguishing the fire and terminating the test.

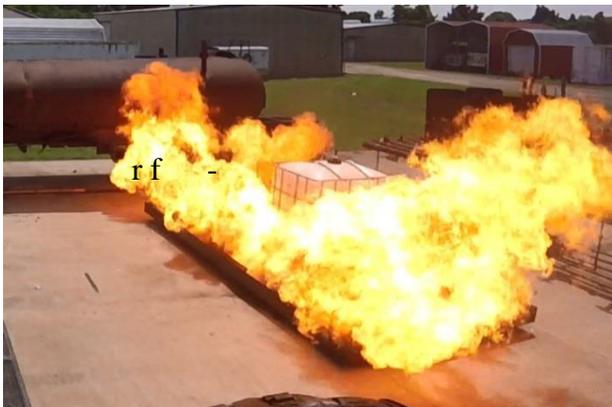
Figure 3.5: Fully ignited vapor cloud

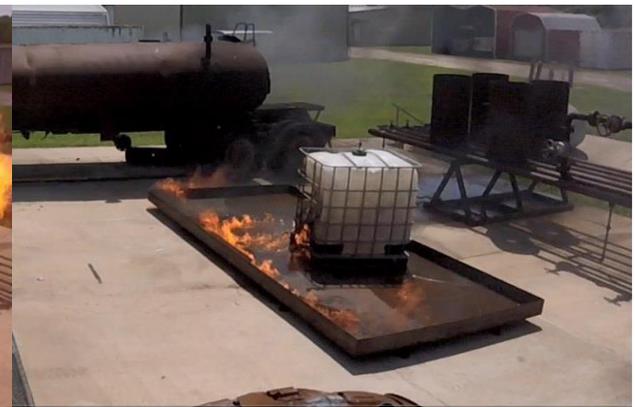
Figure 3.6: Pool fires and burning IBC following flare-up

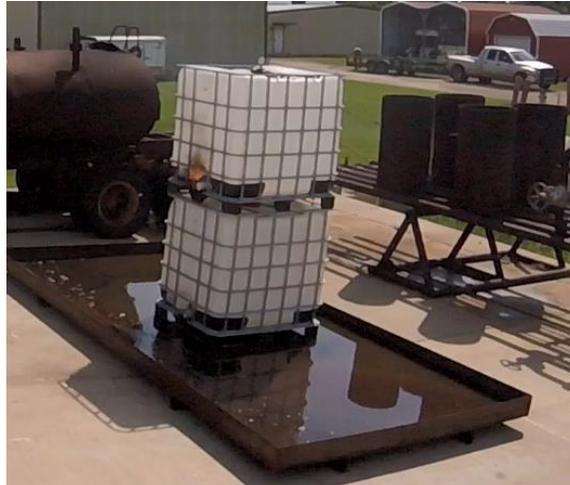
Figure 3.7: Second Tier IBC Set-up

Following the results of the first kerosene test, a second test was conducted with the filled IBC and rolled cotton igniter moved to a second tier IBC (Figure 3.7). The first tier IBC was clean, dry, and free of ignitable liquids. The second tier IBC was clean, dry, and filled with 10 gallons of kerosene. After filling the second tier IBC, the totes were positioned on the steel containment pan and left in direct sunlight for approximately 30 minutes before the test was initiated.

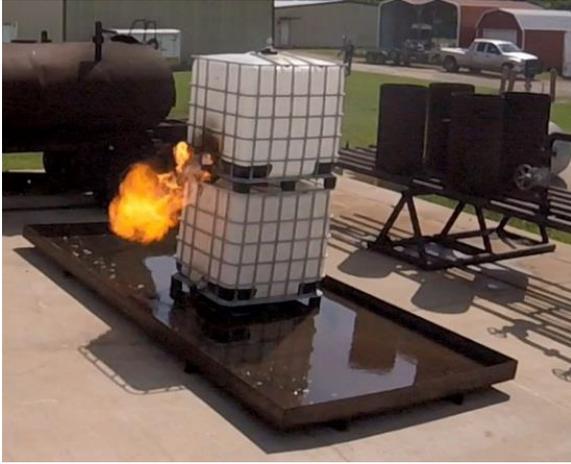
Figure 3.8: Tote inflation and initial vapor release

The test began with the ignition of a rolled cotton igniter. At 2 minute and 41 seconds, a major flare-up occurred. A simultaneous inflation of the second tier IBC and rapid release of partially ignited vapors occurred (Figure 3.8). The vapor cloud was ignited, and the resulting ball of fire extended nearly 30 feet beyond the edge of the containment pan (Figures 3.9 and 3.10). After the flare-up, a pool fire formed on one side of the stacked IBCs and both IBCs began to burn (Figure 3.11). Within 20 seconds of the initial flare-up, both IBCs and the entire containment pan were engulfed in flames (Figure 3.12). A firefighter intervened at 3 minutes and 54 seconds and was eventually able to extinguish the fire.

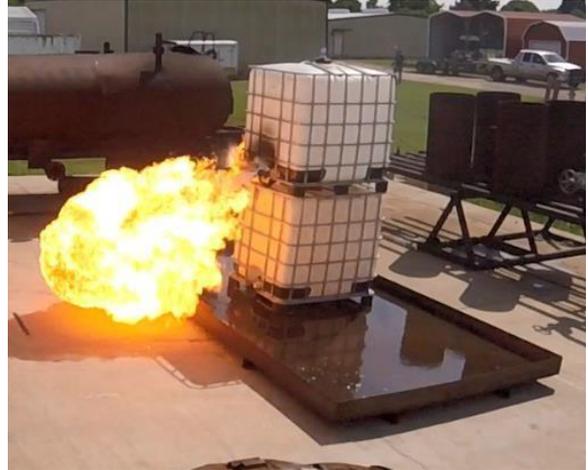
Figure 3.9: Vapor ignition

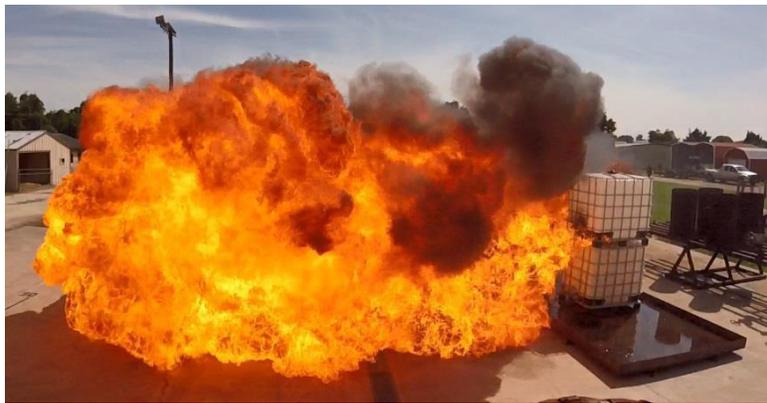
Figure 3.10: Ignited vapors create fire ball extending nearly 40 feet

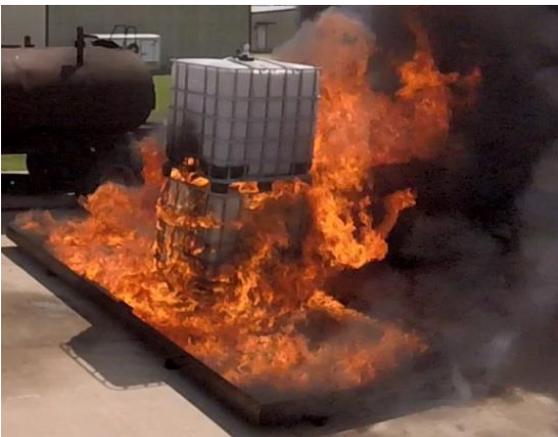
Figure 3.11: Pool fire fully consumes IBC totes

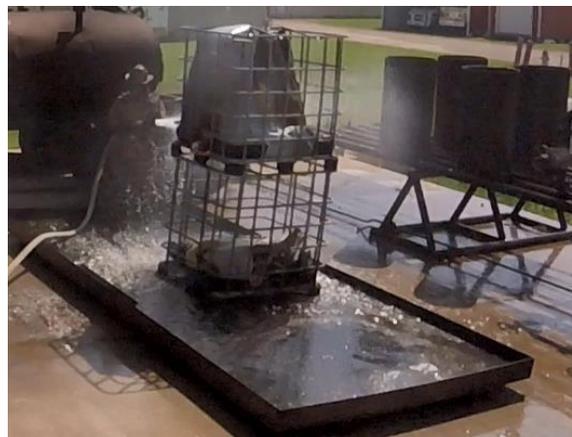
Figure 3.12: After extensive fire-fighting, IBCs are extinguished
